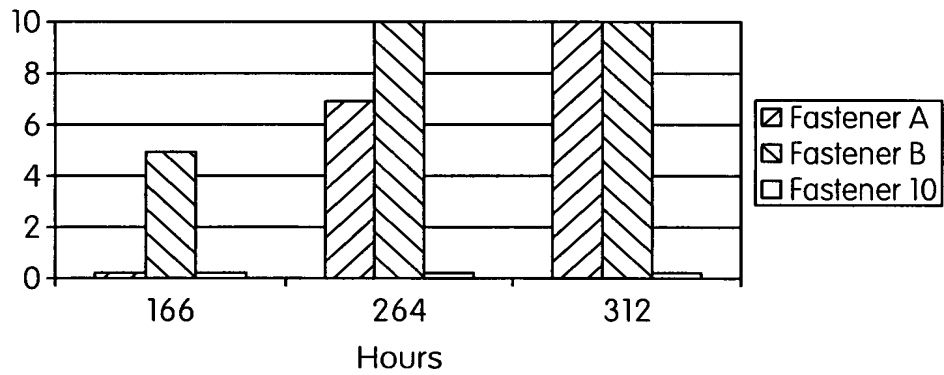
FIG. 8

Results of ASTM B 117 Salt Spray Test  
# of Nail Heads Showing Red Rust

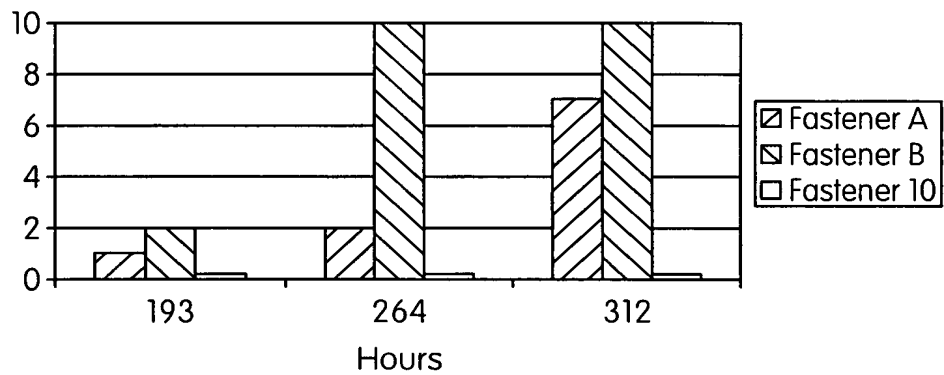
FIG. 9

Results of Driven Fastener ASTM B 117 Salt Spray Test  
# of Nail Heads Showing Red Rust
